Tararua District Council

Laws Road Reservoir - ROV / MS1000 Sonar Inspection

9<sup>th</sup> September 2024

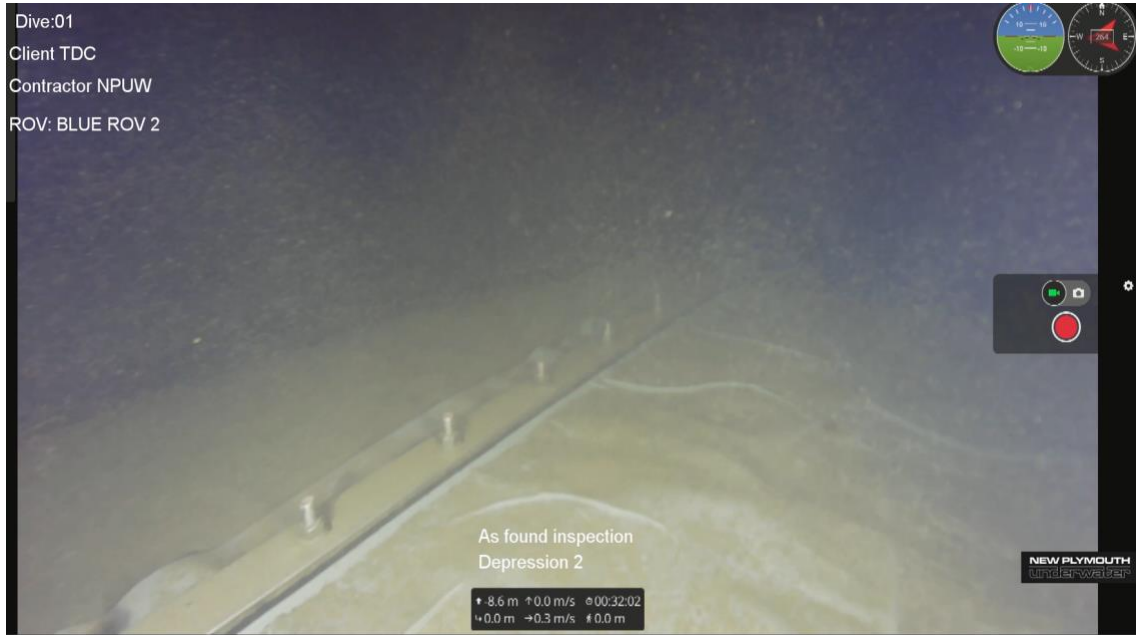
No further movement was found on the diver repair. The eastern face slump remains 150mm x 800mm. The southeastern corner depression was re measured at 5.169 m<sup>2</sup>. The movement found in previous appeared to have ceased.

Image 1 Depression 2 west face

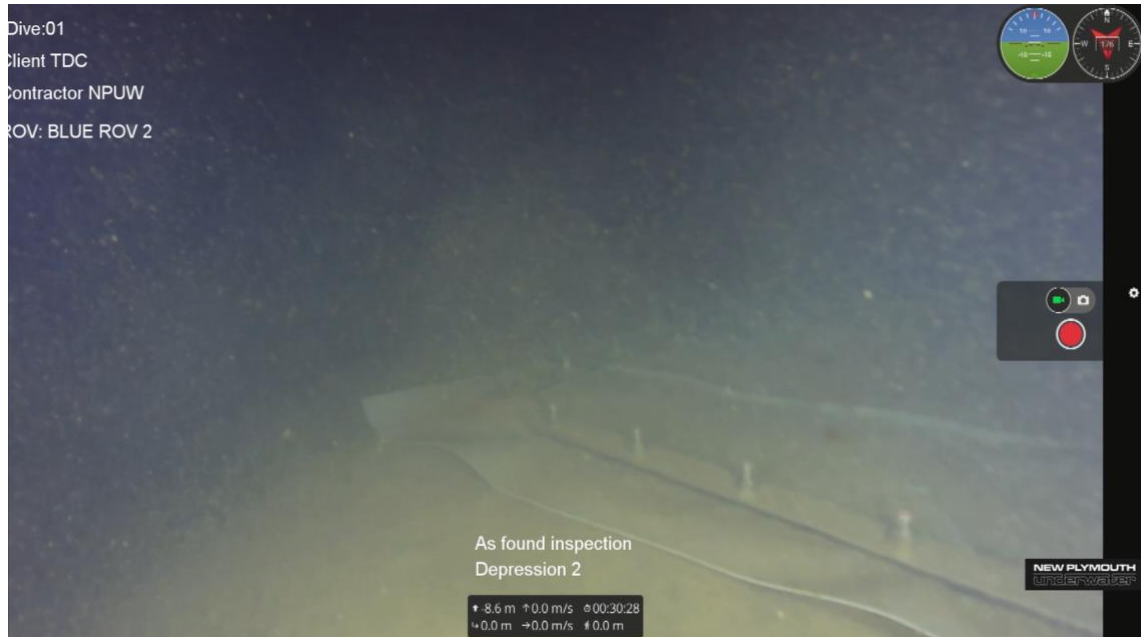
Image 2 Depression 2 South east corner

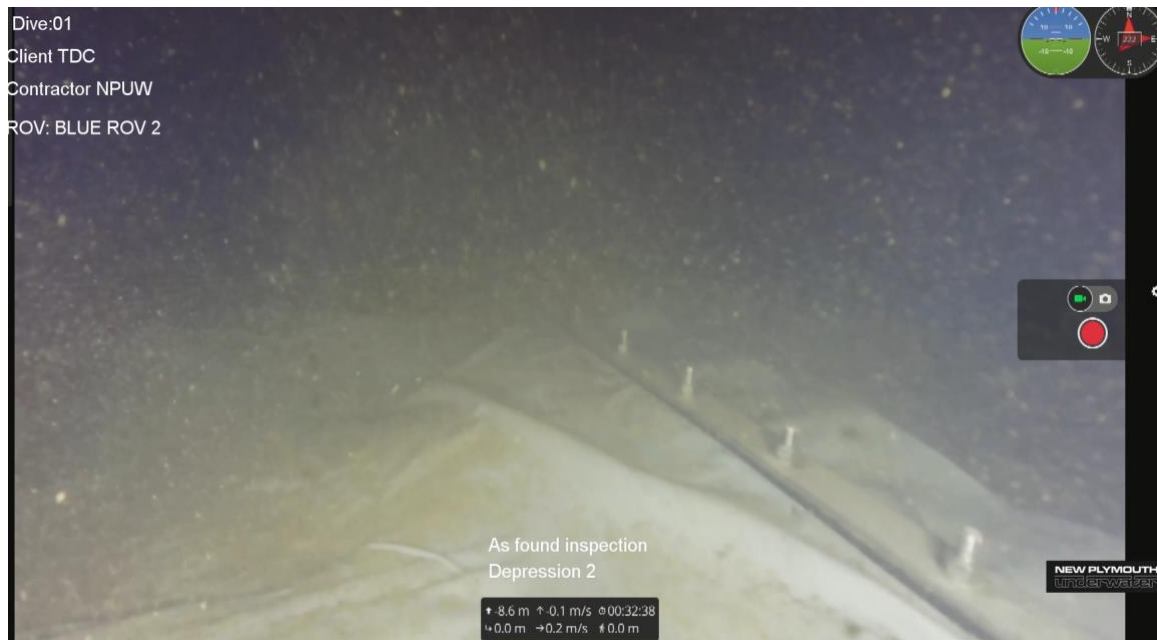
Image 3 Depression 2 north west corner

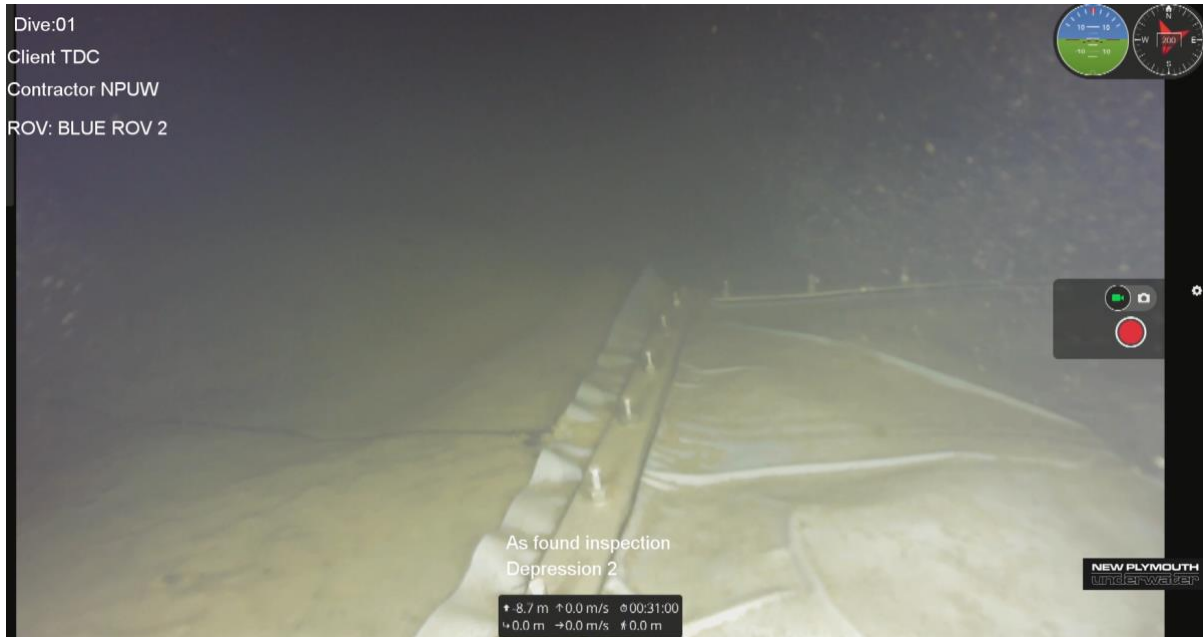
Image 4 Depression 2 East face

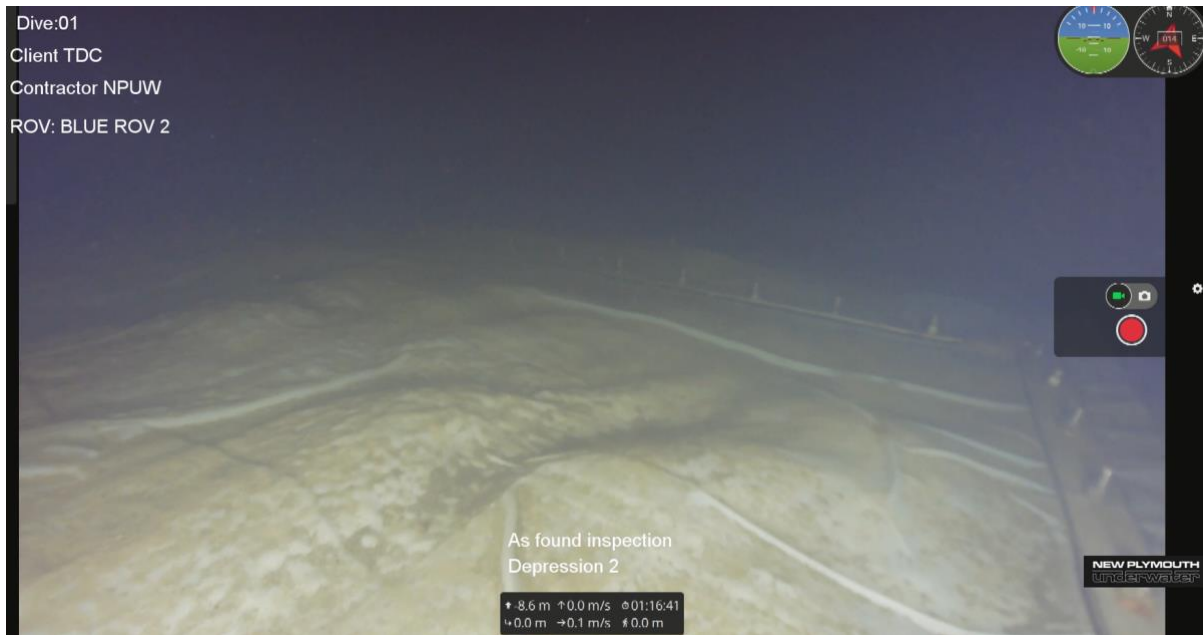
Image 5 Depression 2 Overview

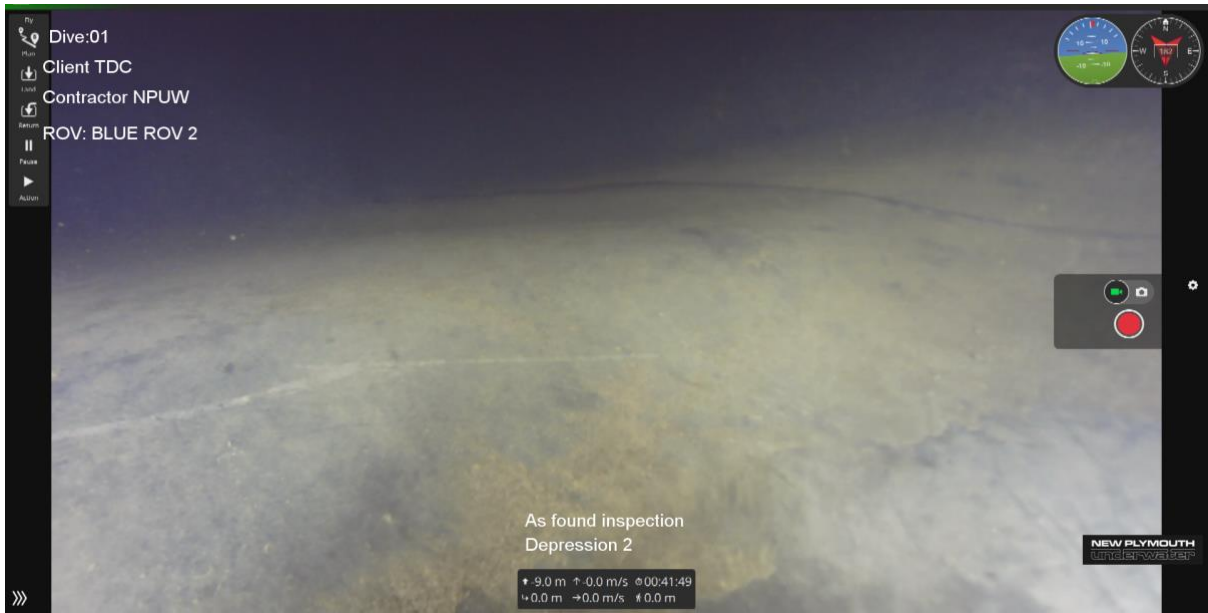
Image 6 Southeast depression 2 100mm movement

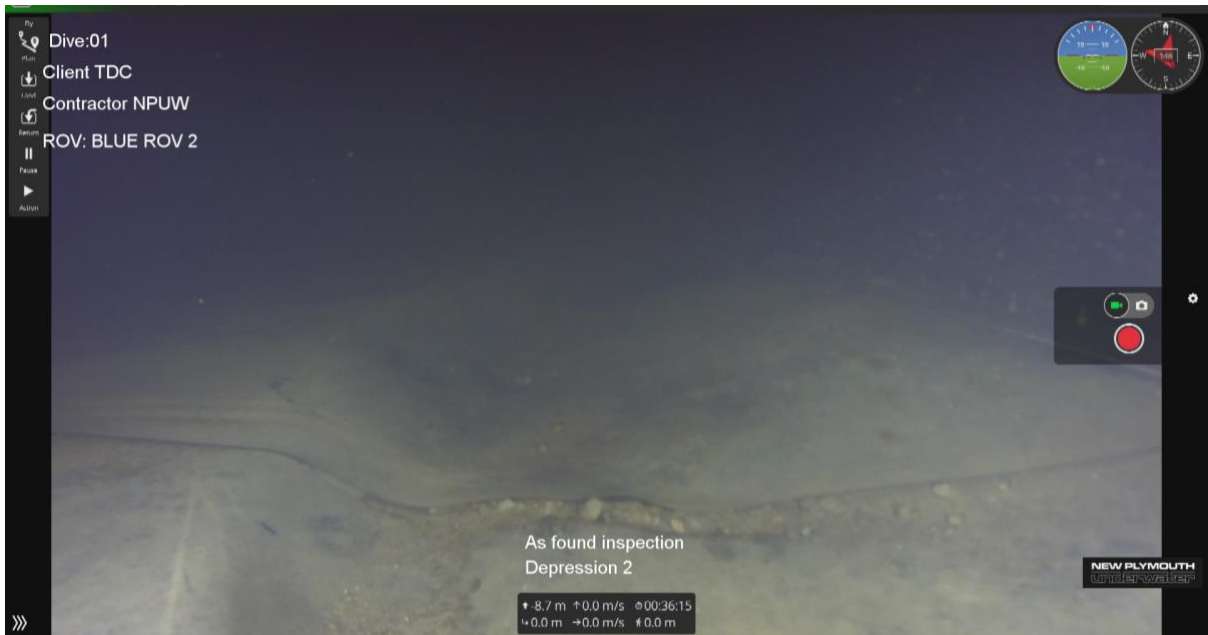
Image 7 East face slump

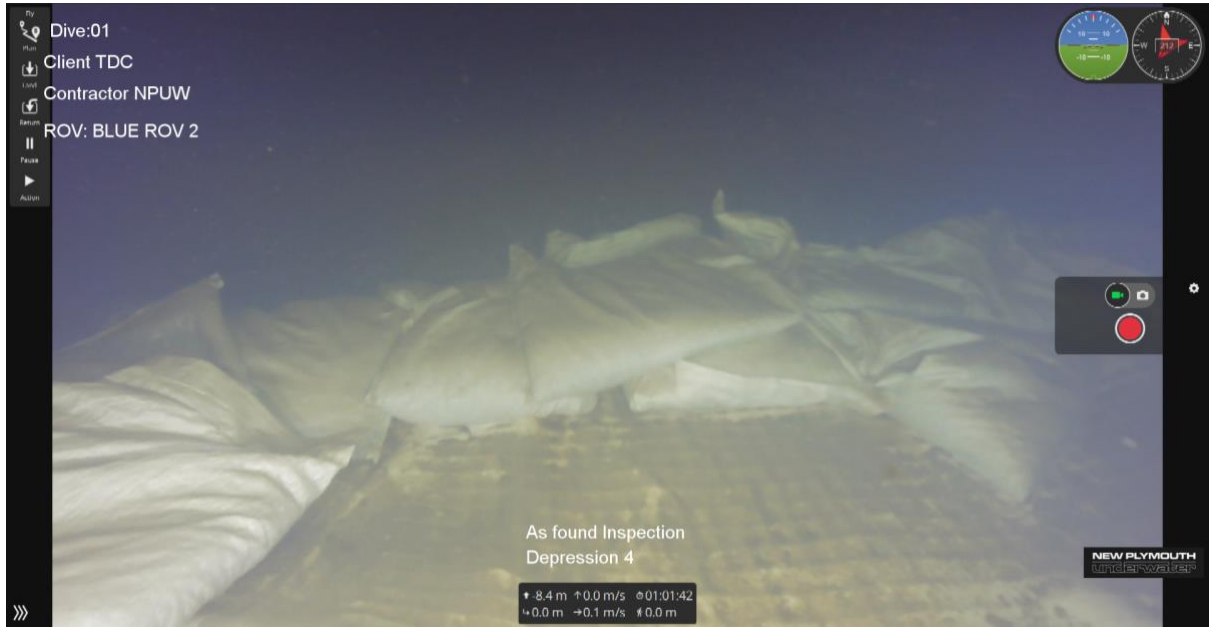
Stage two repair appeared to be in good condition. The southeastern corner was re-measured to 7.730m<sup>2</sup>. Pinhole five remains sealed with pinhole four exposed. No change in pinhole four was detected.

Image 8 Depression 4 South west corner

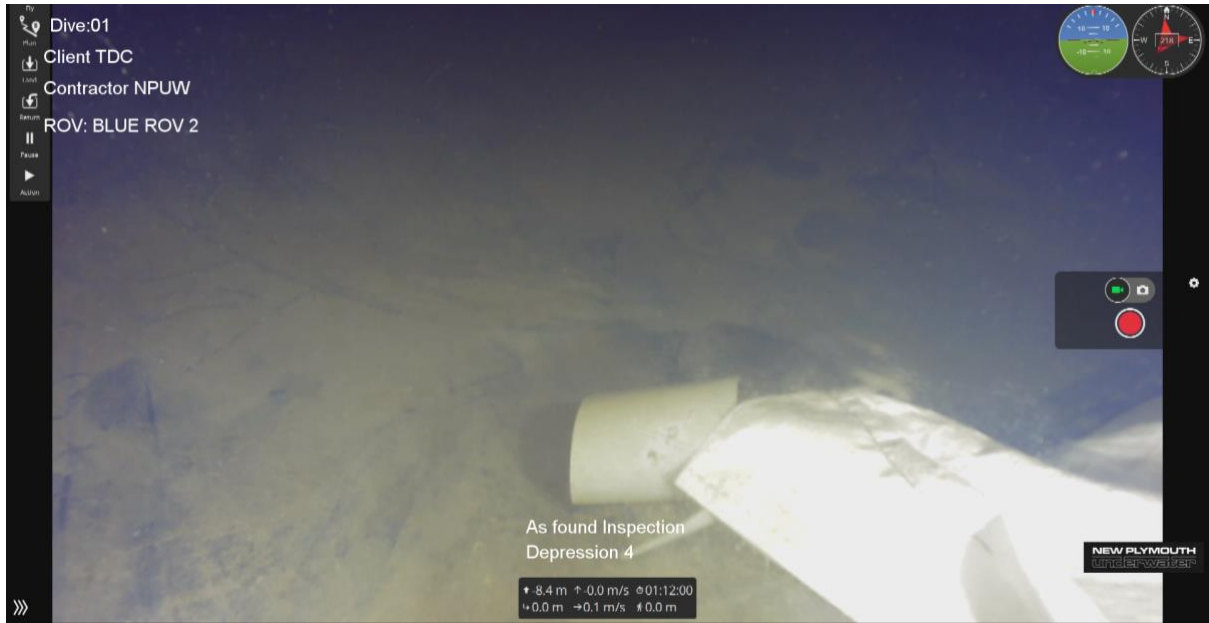
Image 10 Depression 4 Pinhole 5 Butyl tape covering pinhole

The inspection revealed that depressions 5, 6, and 7 require further attention, as these areas cannot be effectively monitored. New Plymouth Underwater (NPUW) has been contracted to remark these depressions with divers for future inspections. Additionally, NPUW has recommended that all depressions be re-inspected, with repairs required for pinholes 4 and 5.

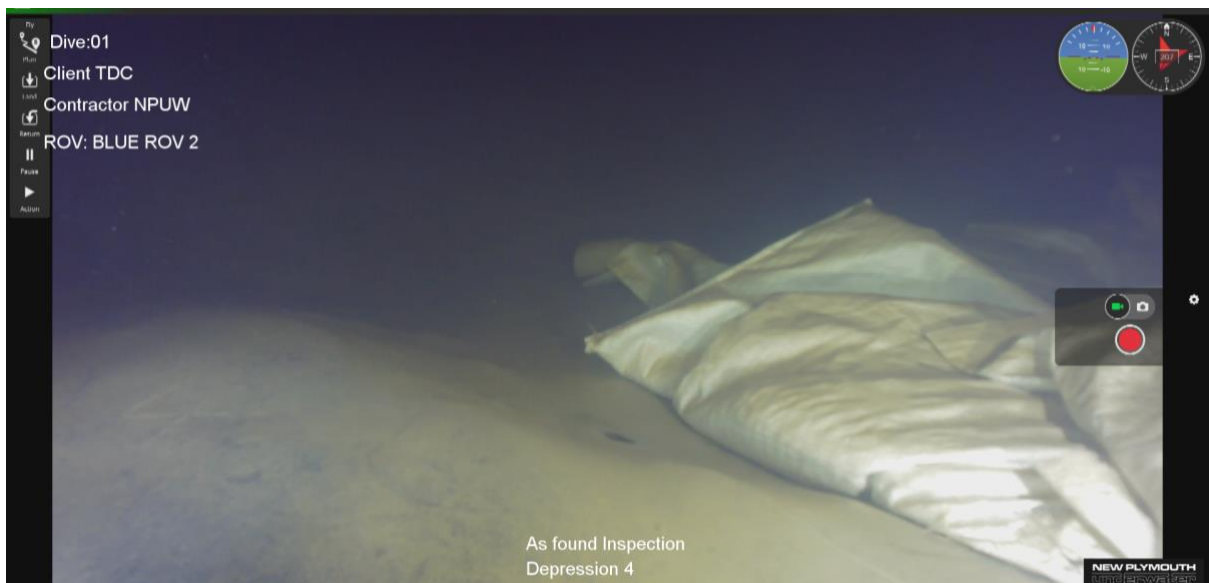
Image 11 Depression 4 Pinhole 4

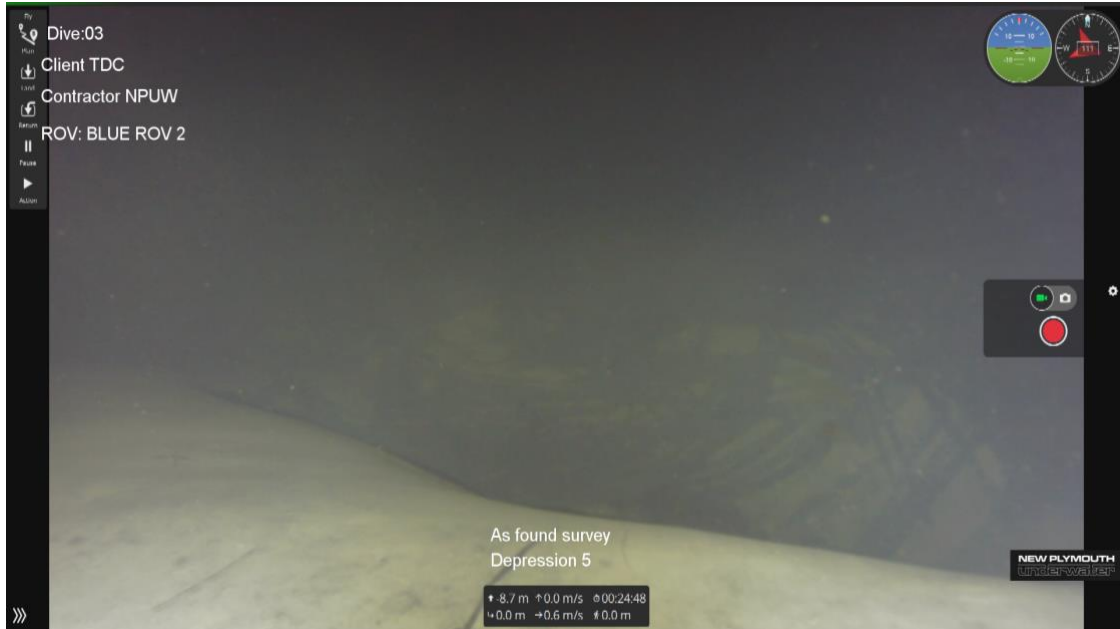
ROV operator was unable to locate a consistent chalk line previously marked out by divers, making movement impossible to detect. All cardinal points were inspected followed by an internal inspection. No tears or leaks were identified. Depression was re-measured to 10.162 m<sup>2</sup>

Image 12 Depression 5 main depression

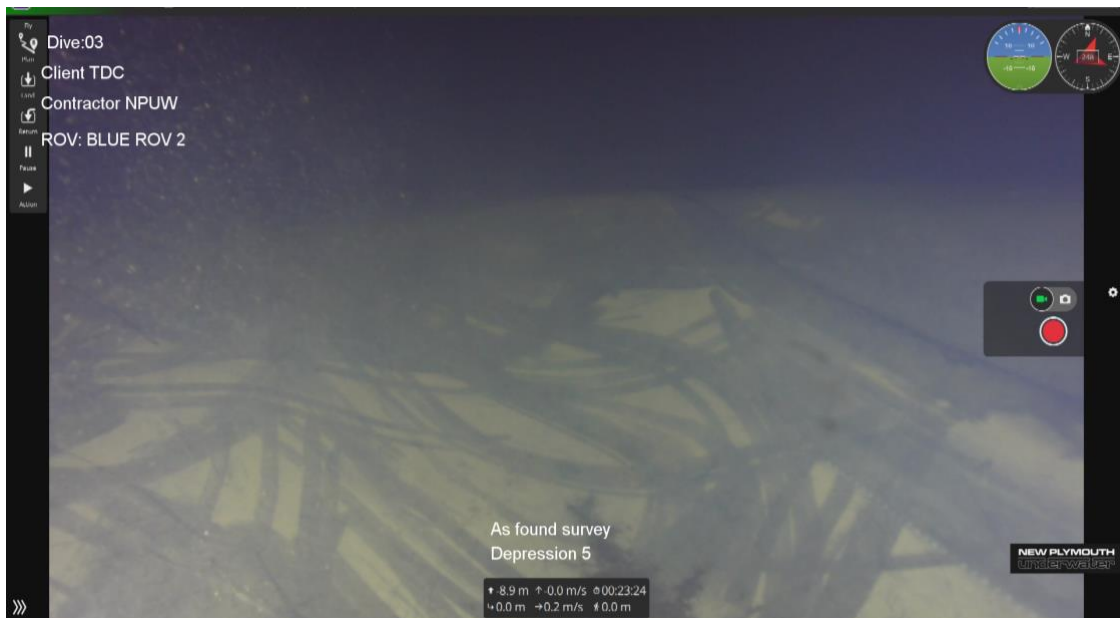
Image 13 Depression 5 internal

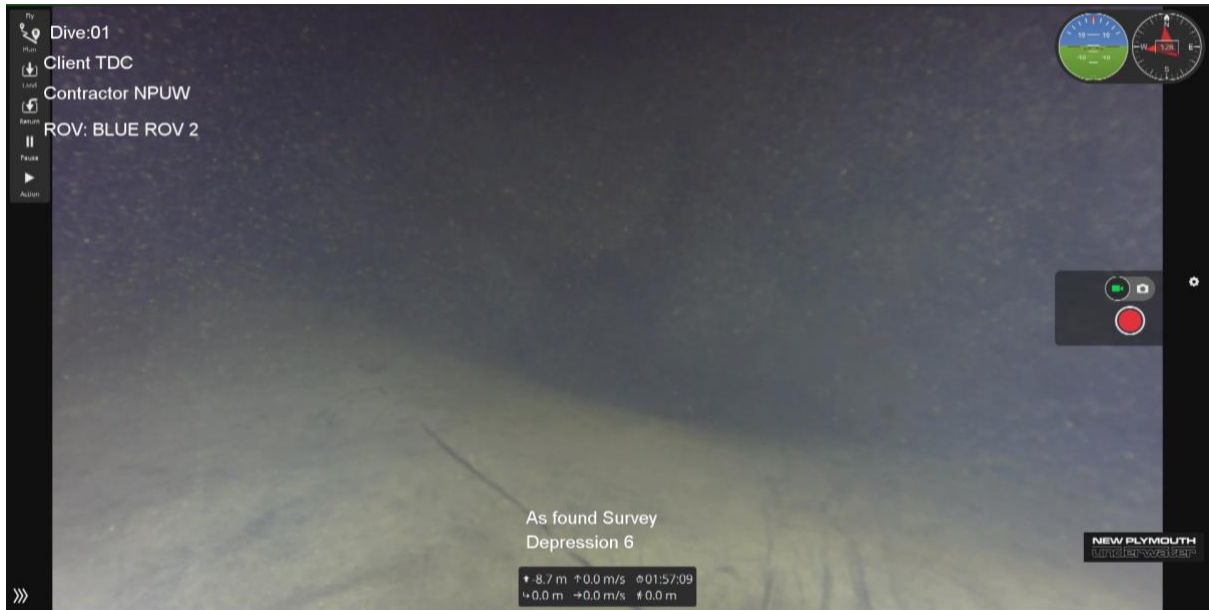
No chalk lines visible on depression six. Depression was re measured to 2.732 m<sup>2</sup>

Image 14 Depression 6 South east view (no chalk lines)

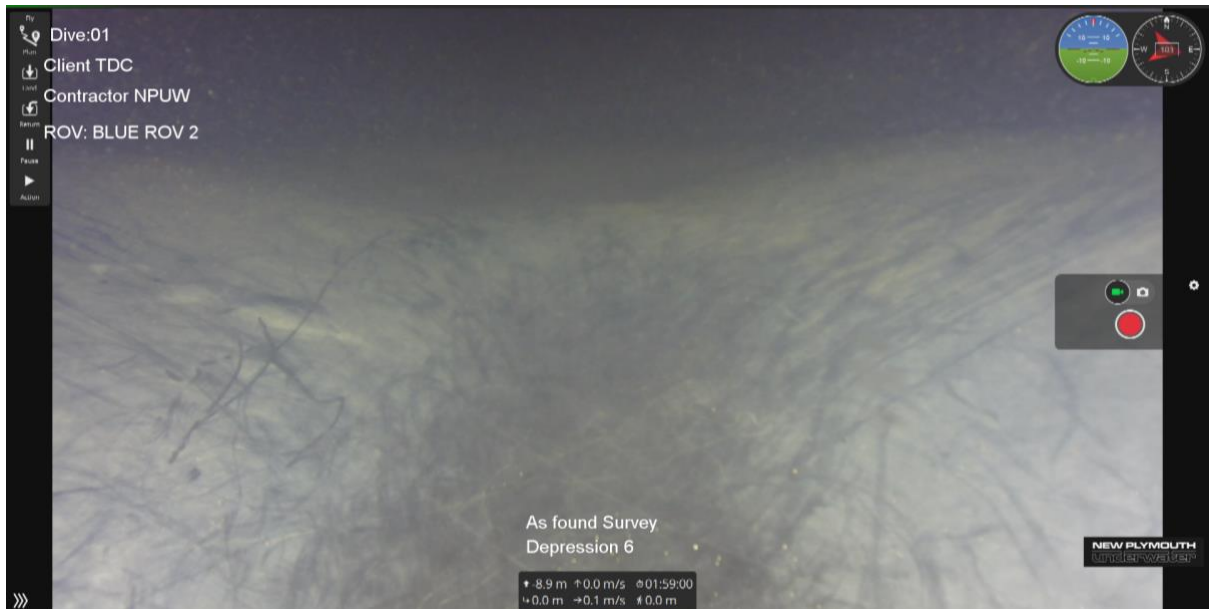
Image 15 Depression 6 internal

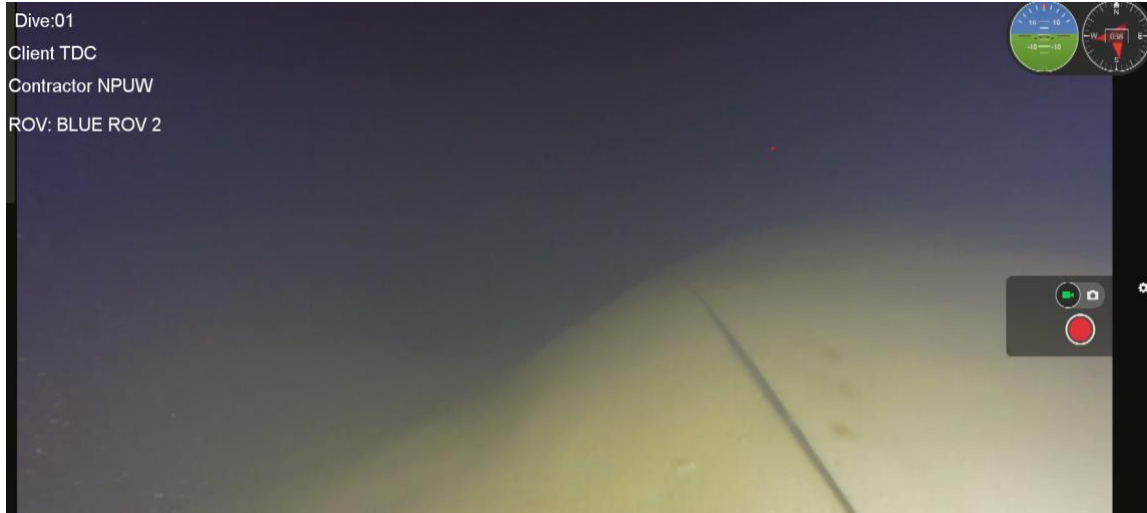
Depression seven appeared to be consistent with the previous survey. Depression was re-measured to 17.187 m<sup>2</sup>

Image 16 Depression 7 North east view

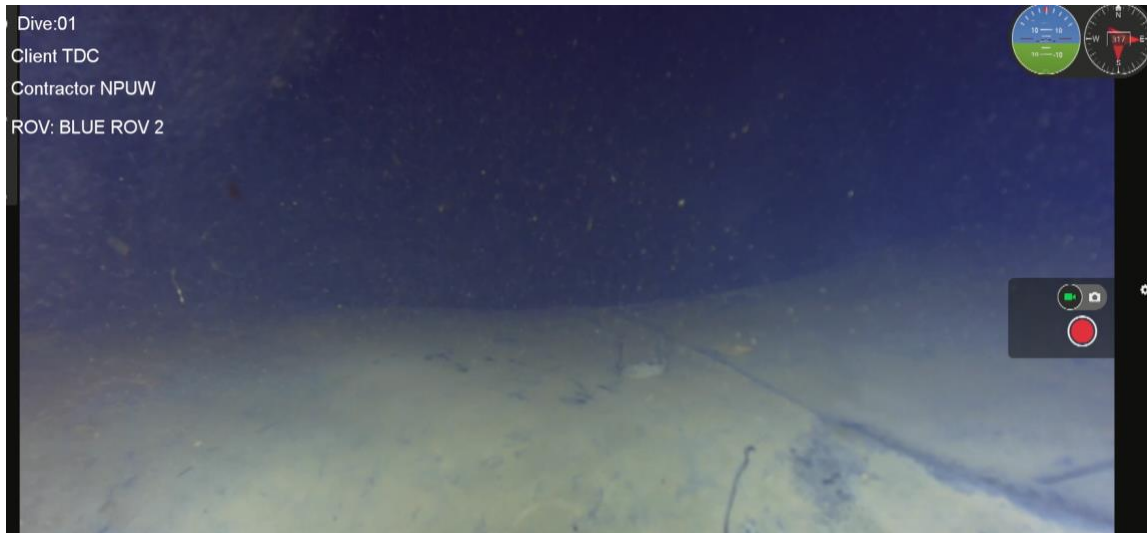
Image 17 Depression 7 north west view

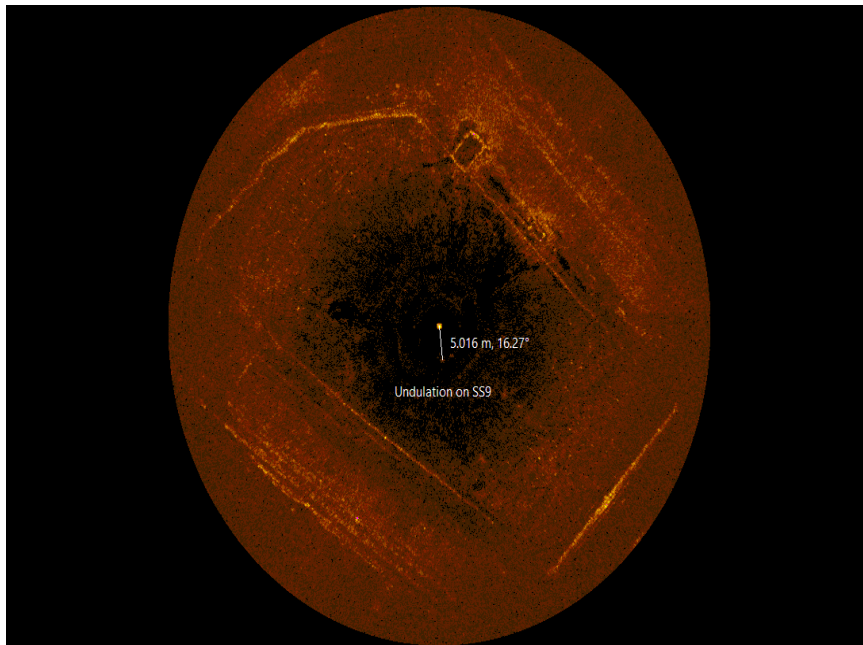
The survey revealed no additional depressions; however, it appeared natural undulations in the terrain were forming above sub soil drainage line nine.

Image 21 Undulation location below subsoil drainage line 9

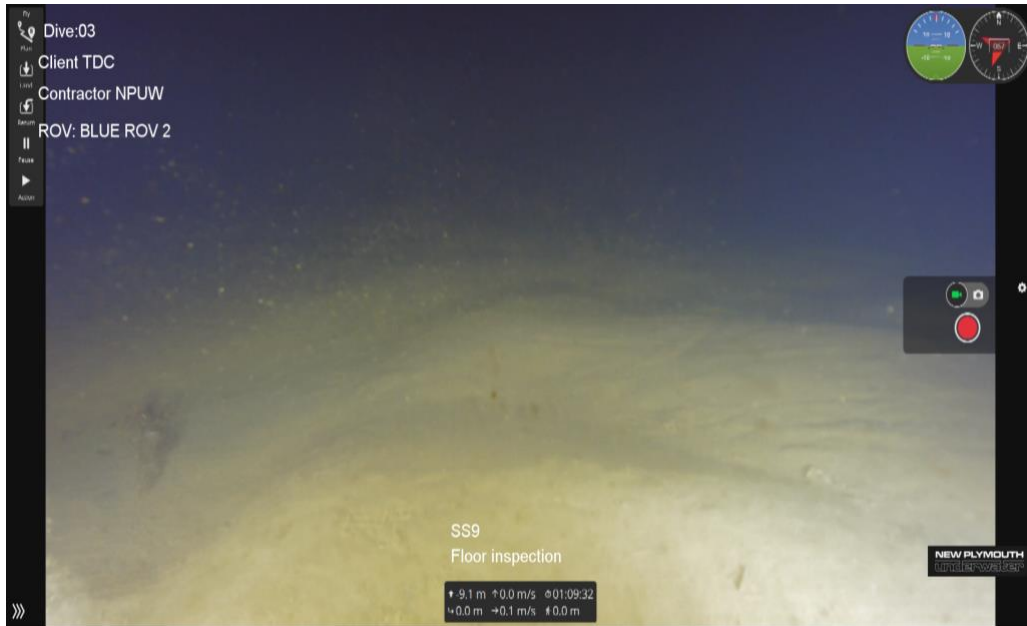
Image 22 Undulation above subsoil drainage line 9
