Tararua District Council

Laws Road Reservoir - ROV / MS1000 Sonar Inspection

9<sup>th</sup> September 2024

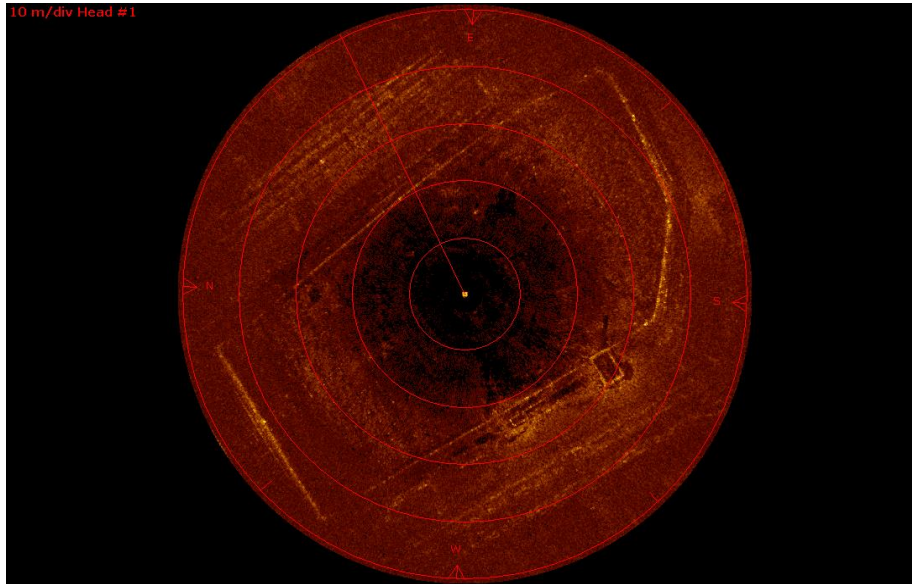
Image 18 360 Degree scan of reservoir floor and batter faces

The only notable irregularity observed was undulation listed below in the reservoir floor and batter face inspection.
